Water Tower Briefing Report

SHQ - Hargreaves, John
Lancashire Fire and Rescue Service
8/31/2017

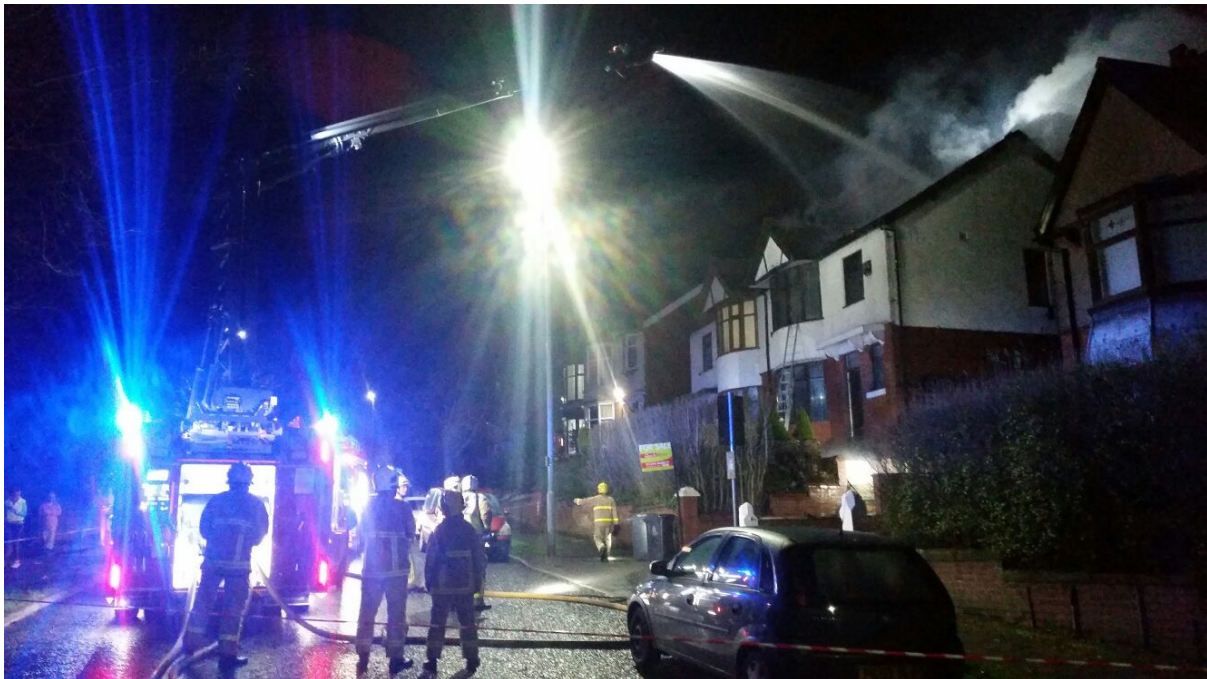
Fig 1

This was the first incident the water tower was used. On arrival of the first pump a radio message was sent to the second pump to say, flames are coming through the roof, be ready to set up water tower immediately on arrival. BA crews from the first pump carried out a search procedure, but found no casualties as the house was unoccupied. On seeing the intense fire in the roof space, BA crews exited the building. As they came out the front door the water tower had set up and was applying water, (Fig 1) which immediately extinguished the fire. The crews stated that, from arrival the water tower took six minutes to set up and extinguish the fire. Due to a quick response, not only was the neighbouring house saved, the structure of the house on fire was also saved. The house only required new roof structure.

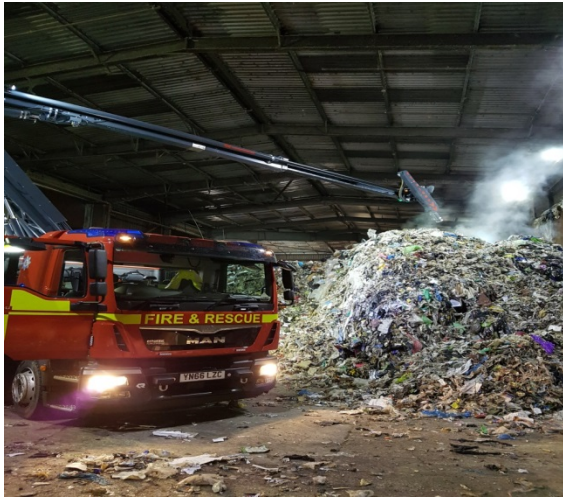
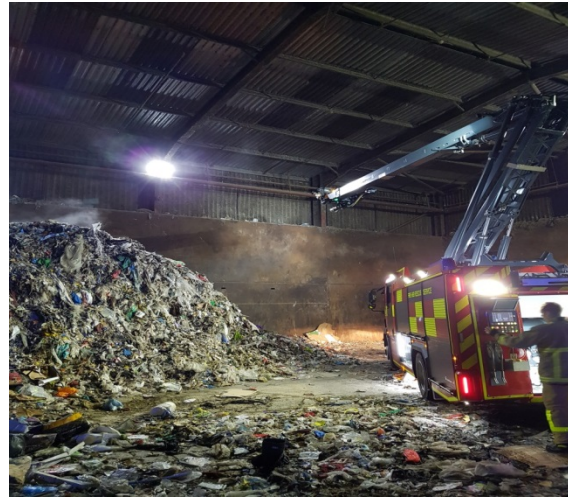
Fig 2

At this incident the photos (Fig 2 & 3) show that the water tower could gain access into the building and set directly alongside the smouldering waste material. There was sufficient height to raise and position the boom over the pile of waste. The hydraulic spike was deployed into the waste and delivered 1000 litres of water, the pile was flooded and fire extinguished. Clearly an alternative method of dealing with such incidents. This avoided the need for firefighters having to manually separate material negating physical effort, increasing firefighter safety, reducing attendance time and increasing appliance availability.

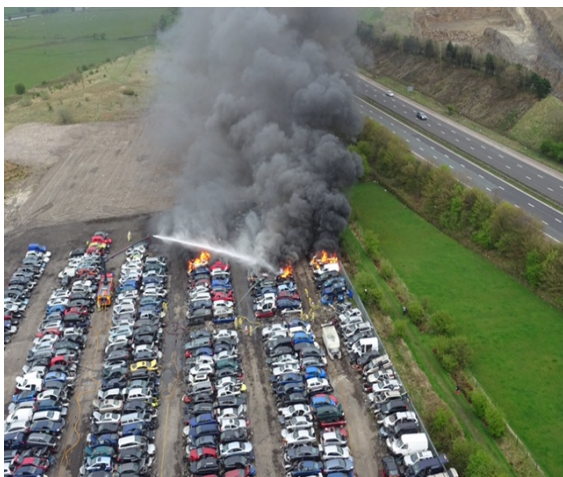
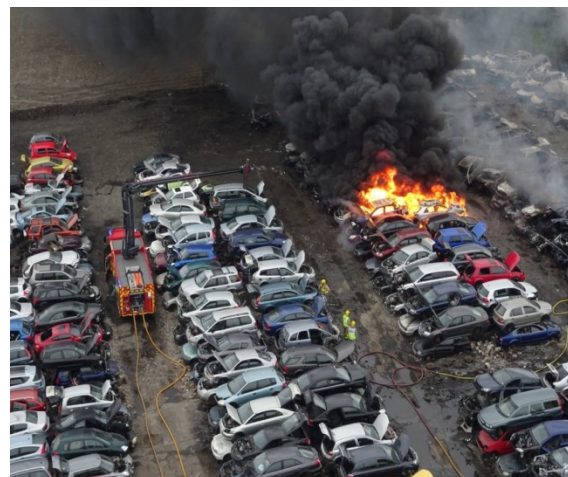
Fig 4

Although the fire was in one area of the compound, it had spread across spread three rows of cars bridging fire breaks to create separate fires. Access to the sight was poor due to rough ground conditions created by plant machinery. Nevertheless, the water tower successfully gained access to a location safe and set to work. Initial supply of water was poor. However, this was addressed and the water tower delivered a jet sufficient to extinguish all three fires in turn. This demonstrated the capability of jet projection. Key benefits from this incident are, the water tower can travel over rough ground to access restricted/tight areas, can deliver a long jet throw, achieving a strong firefighting jet from a distance, which increases fire fighter safety. Again this incident was dealt with quickly avoiding the spread of fire into other surrounding car recycling businesses. The pictures below (Fig 4 & 5) show the appliance location in relation to the three fires with the motorway, which was not closed, in the background.

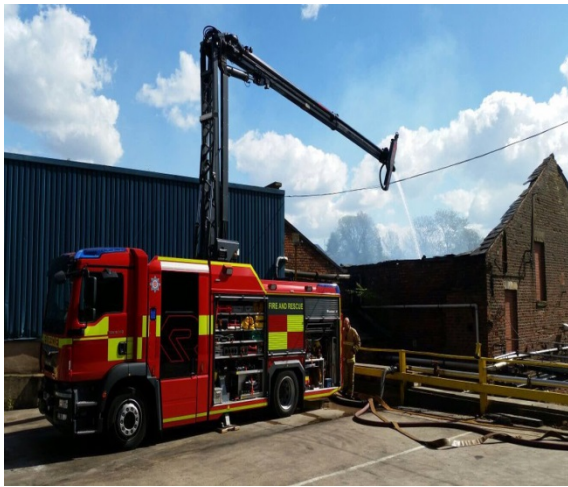
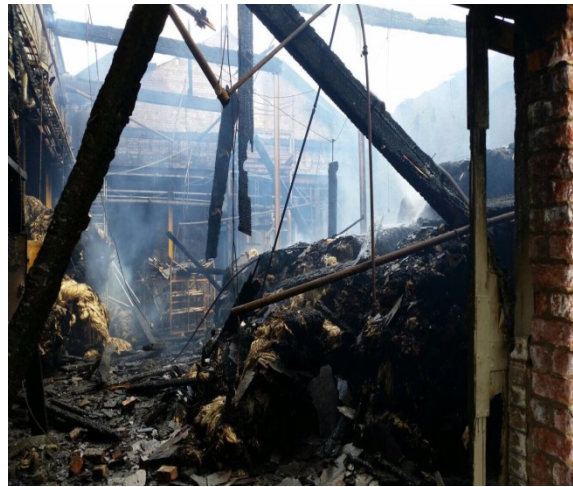
Fig 6

better accessibility over an ALP. Given the close position achieved to the fire (Fig 6 & 7), the WT jet can reach the whole area to maximum water application resulting in a quick knock down. The benefit of operating from a distance keeps firefighters in a safe zone away from dangerous structures.

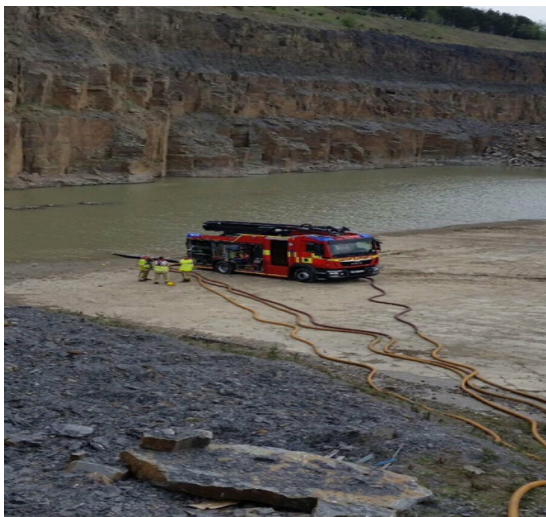
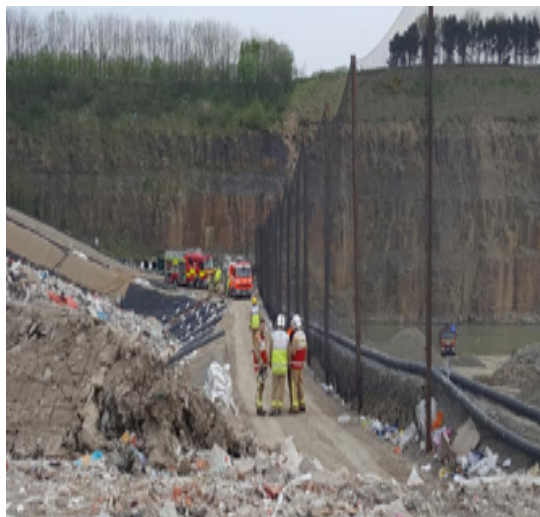
Fig 8

The WT was called to this incident to act as a base pump to feed two other appliances. The photo (Fig 8) shows the WT positioned at the water's edge at the lower level of the quarry floor. The 5,500 L pump delivers water through four 70mm hoses to two appliances positioned at a higher level, which then feed two firefighting jets to the fire. The benefit identified is the WT has the capacity to operate as a High Volume Pump (HVP) and is quicker to deploy than the current HVP which uses much larger hose. Using the WT as an HVP with 70mm hose would reduce road closures. Operational crews also stated that the WT had the capacity to directly feed the firefighting jets, therefore removing the need for the two appliances seen on the photo (Fig 9).

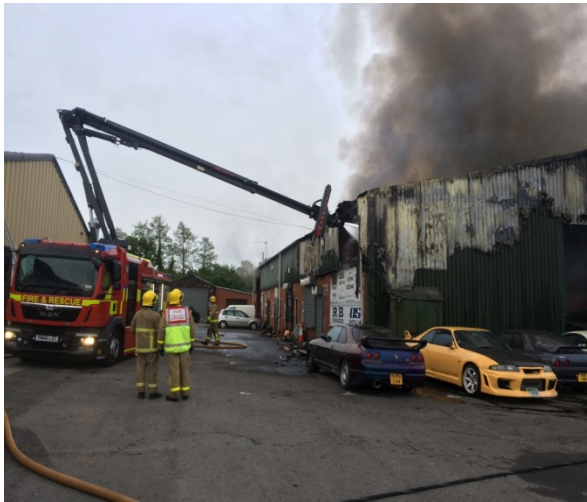
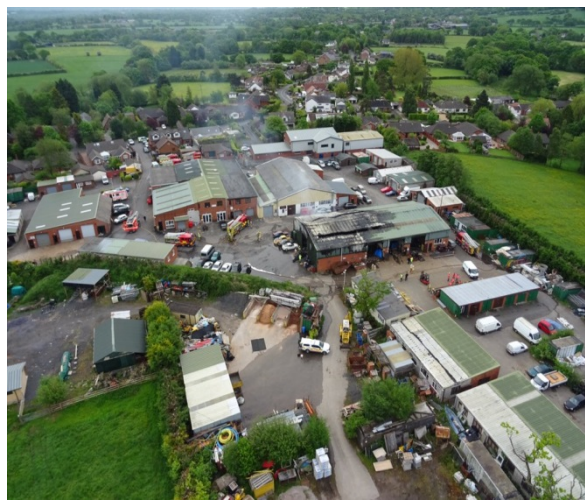
Fig 10

The vehicle Workshop contained cylinders so the WT was used to pierce the roof in three locations at different elevations to cool the temperature inside and the cylinders, doing the work of three separate jets. When using the spike, a 1,000 litres of water is delivered in an atomised condition, thus creating a sprinkler system effect. Sufficient water is delivered to cool and extinguish the fire. By maintaining offensive firefighting throughout the incident, the fire was prevented from spreading into surrounding buildings seen on the photos below (fig 10 & 11). Applying water via the WT to onto the cylinders to cool increased the safety of Firefighters during this incident.

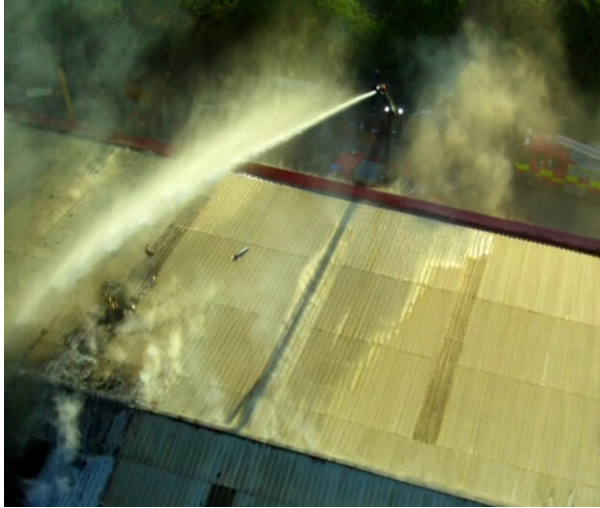
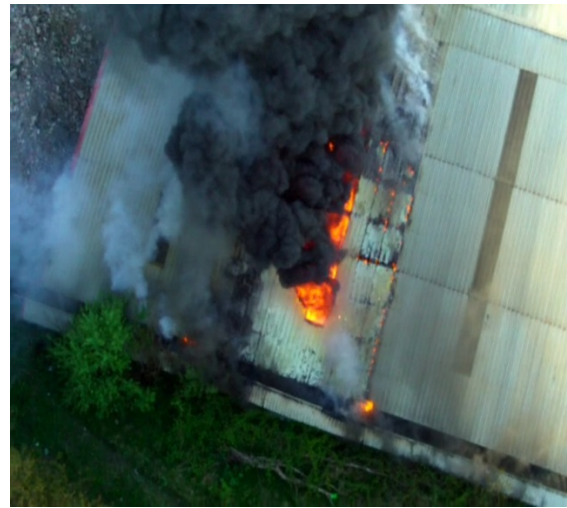
Fig 12

The WT could not access the side of the building on fire due to the railway banking running alongside and a large pile of waste material blocking the access road to the buildings front elevation. The water supply to this area was also poor. However, the building was pierced and temperature reduced from 380°C to 180°C. This was measured using a thermal imaging camera. The reduction in temperature allowed firefighters to gain closer access to extinguish the fire. The WT was later used as a base pump to feed multiple lines in to the fire front.

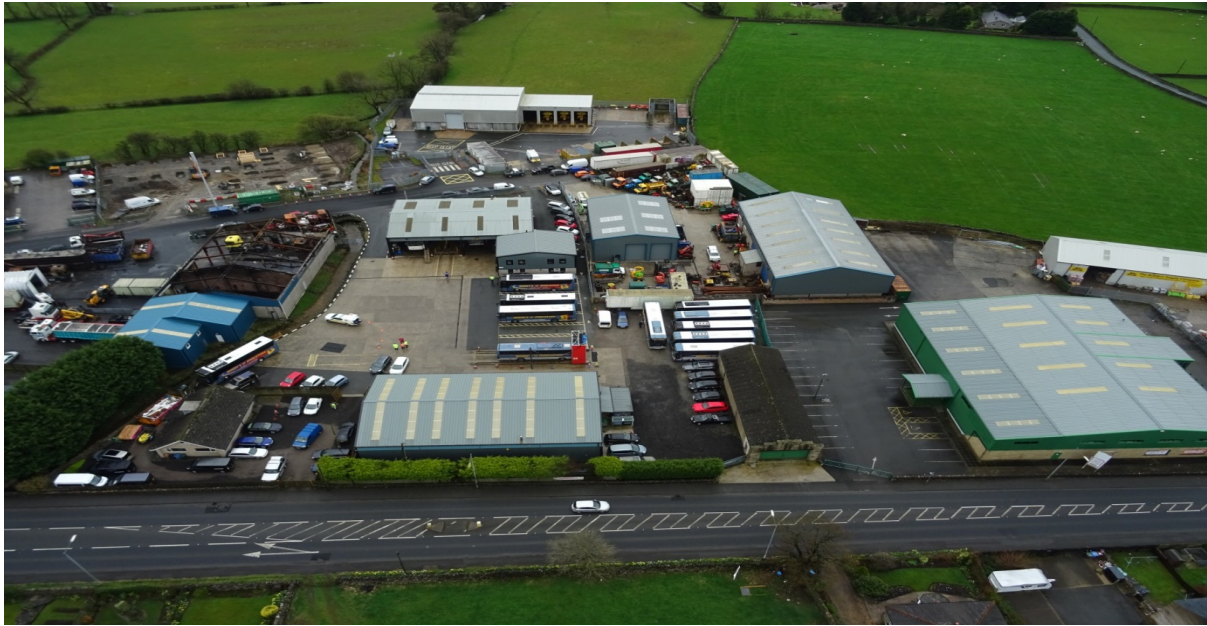
Fig 14

The two blue roofed end units adjacent to the fire on photo (Fig 14), which stored large quantities of engine oil, had been saved, along with the surrounding buildings. During the incident, a large number of coaches had to be moved to the far side of the compound to prevent the fire spreading through the vehicles. It is estimated that £7m of vehicle assets had been saved in addition to the coach company's workshop and surrounding garages. Within an hour of arriving at the scene, the water tower had effectively extinguished all three fires, re-stowed equipment and was on route back to station available for the next incident.

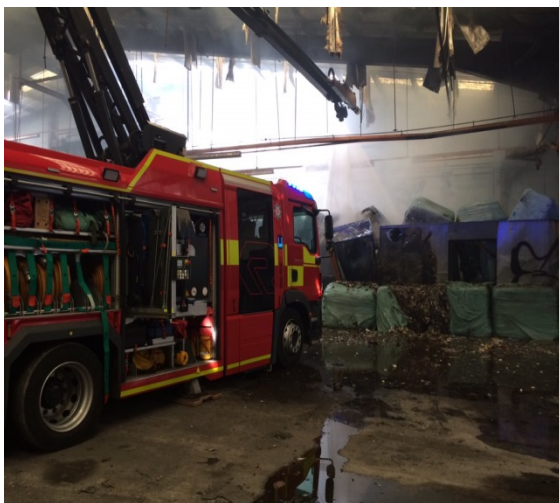
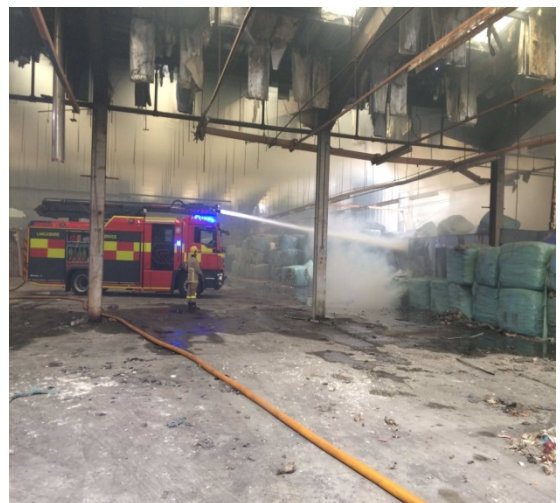
Fig 15

The mill stored bails of domestic and clinical waste. The WT gained access through the building to be face onto the bales. On the initial attack (Fig 15), firefighters stood 20' behind the appliance working in a safe zone avoiding rebounding debris and operated the monitor via the remote to direct a jet of water into the core of the fire. The powerful jet broke up the bails and spread the material negating the need to carry out this task manually, avoiding physical effort and fatigue. The second attack (Fig 16) shows the monitor deployed over the bales to apply water to flood the area, extinguishing the fire completely. This technique avoided the need to cut through the rear building panel to attack the fire from behind. Again the incident was completed within one hour of arrival using minimal resource. The Group Manager in charge stated that this had the potential to develop into a 10 pump incident as a barn fire did on the same day. There are clear benefits of having the water tower capability on initial arrival, which ultimately lead to reduced attendance time and enhance firefighter performance and safety.

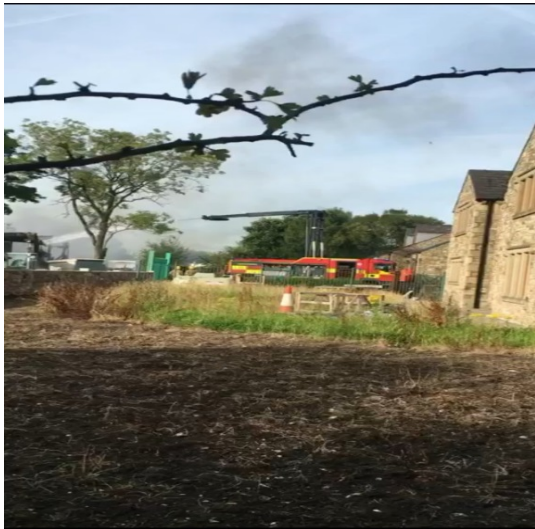
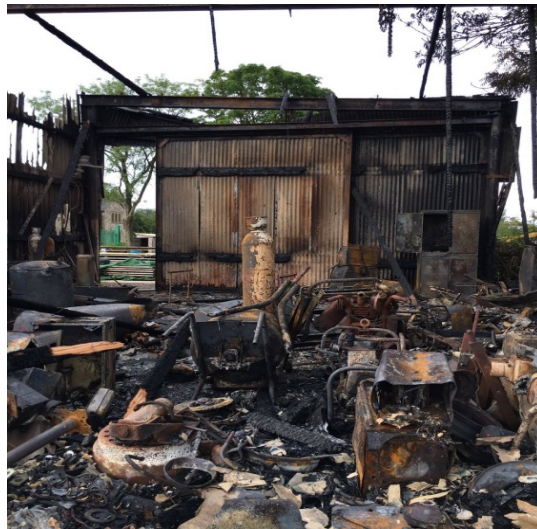
Fig 17

The picture below (Fig 17) shows the most recent vehicle workshop fire in Blackburn. The WT was set up behind the compound wall around the building to protect the crew and vehicle. At this time cylinders inside the workshop were exploding. The fire was quickly suppressed and remaining cylinders cooled and finally extinguished. The picture below (Fig 18) shows one of the unexploded cylinders standing in the centre.

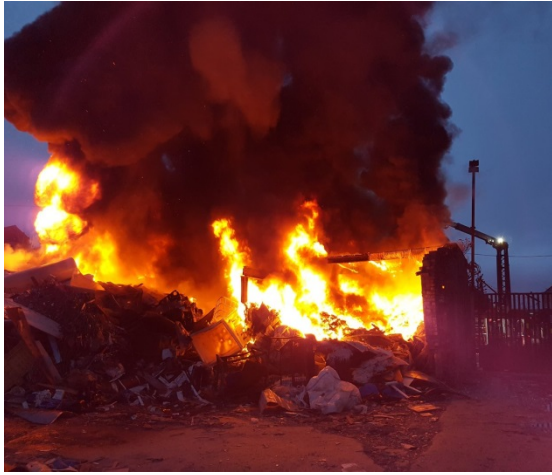
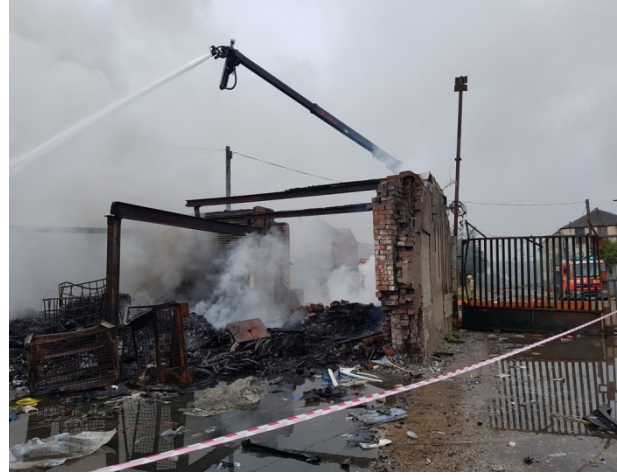
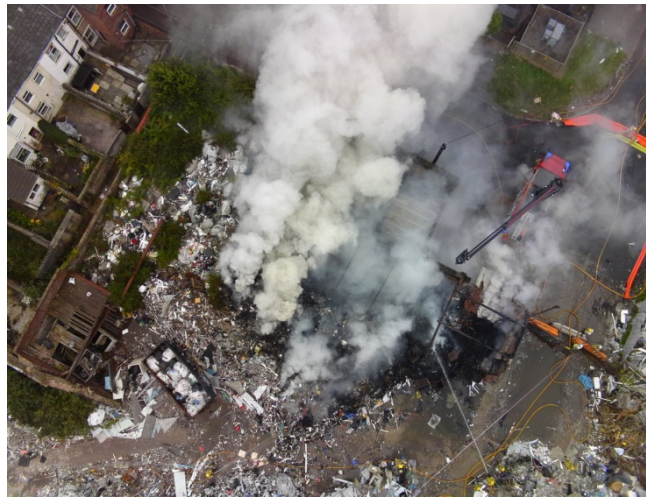
Fig 19

On initial response the WT set up and delivered the full 1500litre tank of water to suppress the fire to prevent significant spread. This bought sufficient time for the crew to locate a dedicated water supply from hydrants and the nearby canal. The wall of the compound was used to protect the crew and vehicle whilst firefighting as seen in the pictures below (Fig 19 & 20). The picture (Fig 21) shows a significant amount of unburnt waste material, which would have easily transferred the fire to the houses situated to the left.

Crews reported that the WT performed extremely well at this incident with regard to being able to set up close to the fire whilst working in a safe area behind the compound wall, achieving a strong firefighting jet to initially suppress the fire and to reach wider areas around the compound to dampen down waste material preventing fire spread. Once again a quick knock down was achieved leading to reduced attendance time, minimal use of resource and impact on surrounding buildings.

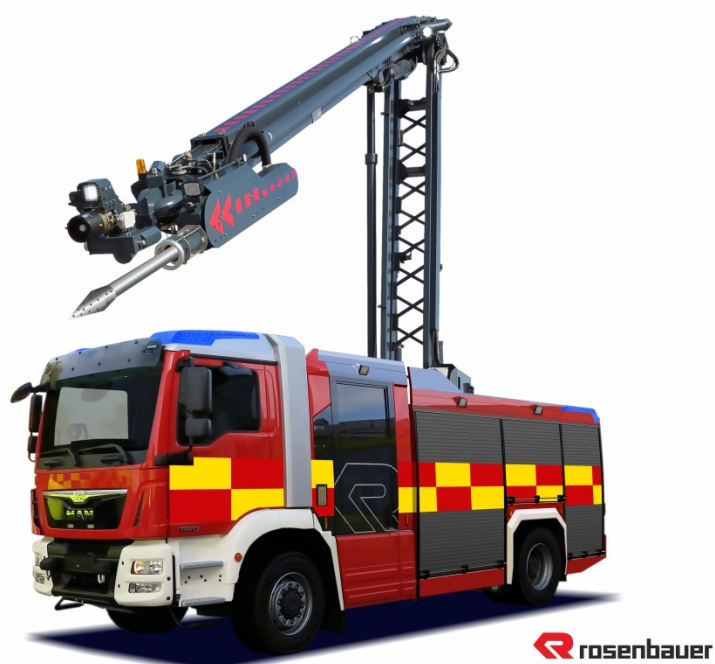
Appendix 1

Rosenbauer Concept vehicle - 2014

In 2012 the Head of Fleet and Engineering Services (FES) was tasked to research alternative water tower appliances. This work led to two options, 1. Dedicated B-type fitted with water tower equipment. 2. Demountable water tower pod body. Whilst the demountable pod body still remains an option, that particular supplier is in the process of building a dedicated water tower to compete with the product being evaluated. The dedicated option being evaluated is shown in **Appendix 1** as a concept vehicle.

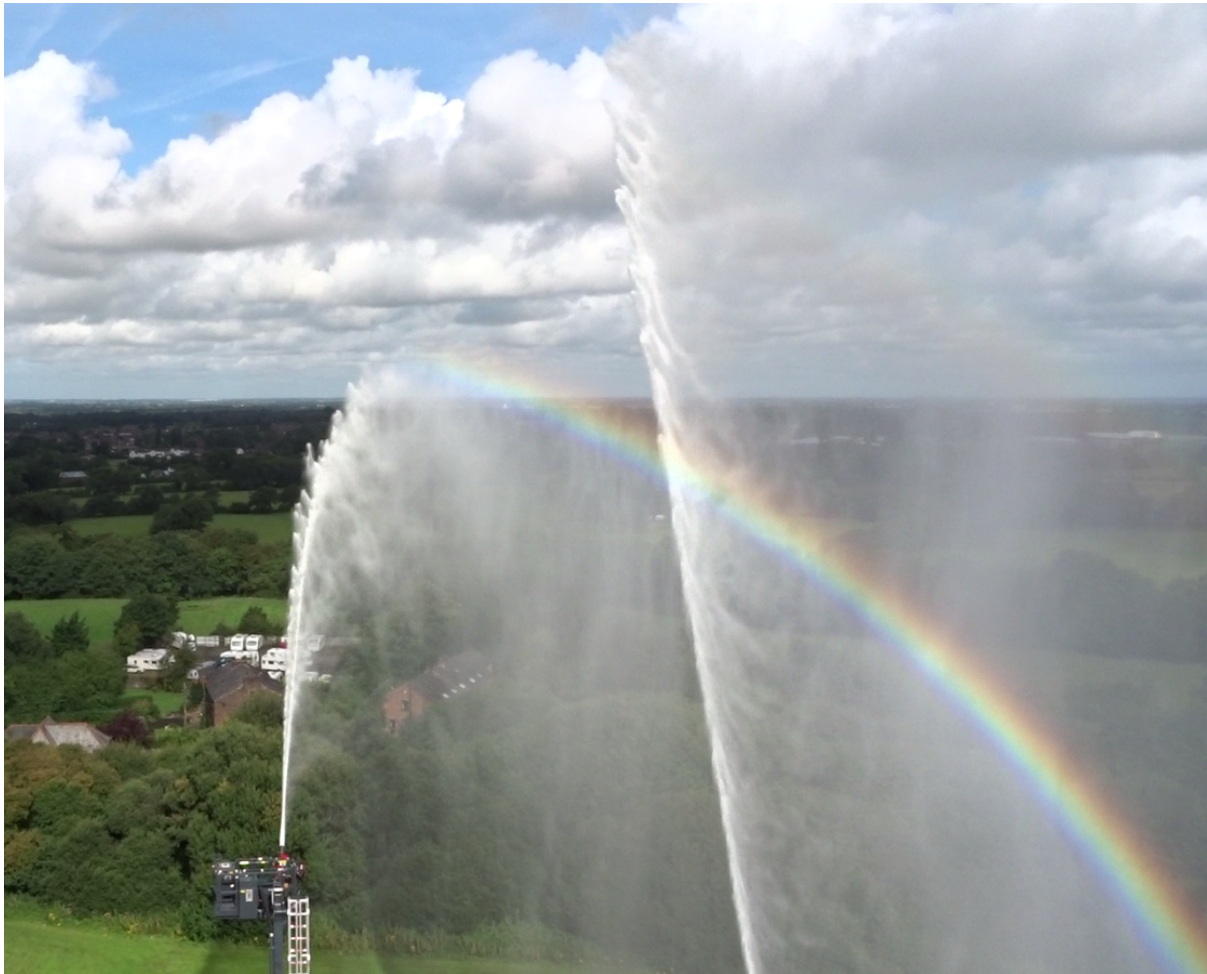
Test 1

Metz ALP @ 32m fed from 1 x PL by 2 x hoses at 12 bar:

Flow 1500 ltr
Height 45m

Stinger at full extension and full power

Height 50m

The outcome of, Test 1, proved that the jet produced from the Water Tower achieved a height of 50m, which is 5m above the ALP performance at 45m. Equipment on both vehicles was at full vertical extension (WT 16.5m, ALP 32m). The ALP was fed in the normal manner (by one appliance) from open water and the WT drew water from the same open supply.

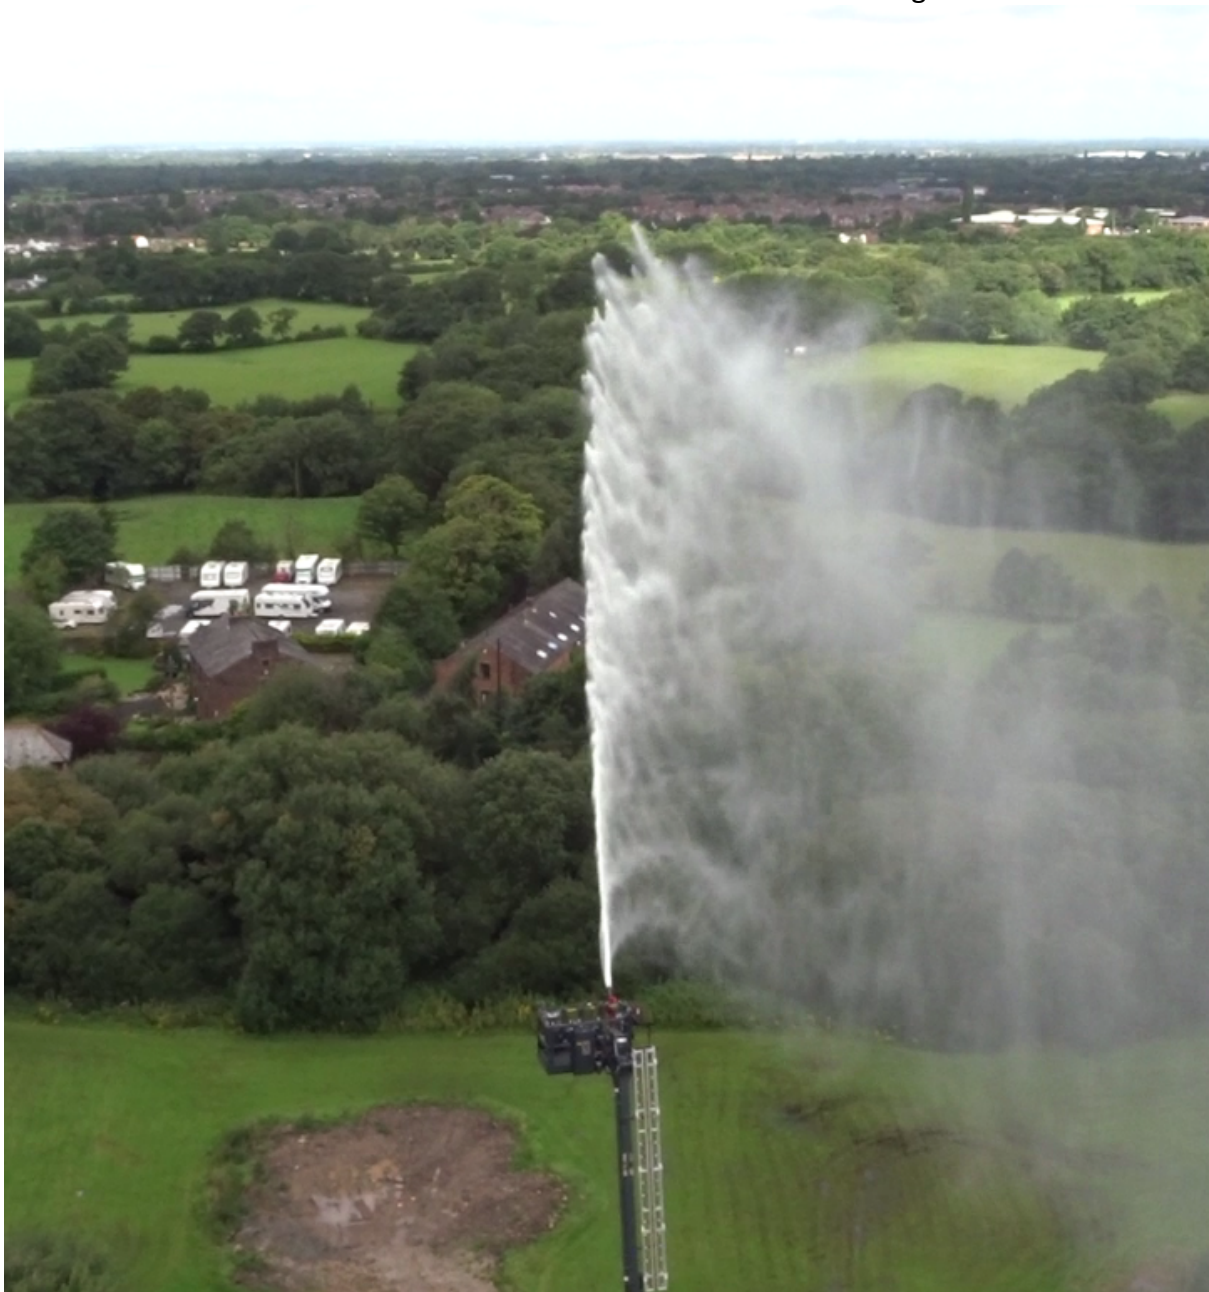
Test 2

Metz ALP @ 32m fed from Stinger by 2 x hoses at 12 bar:

Flow 2000 ltr
Height 53m

The ALP was then tested using the WT as the feed pump, Test 2, and the heights achieved are 53m (2000lpm) using two lines in, and 54m (2600lpm) Test 3, using four lines in. This test proves that, the ALP performance can be improved when using the WT larger 5,500lpm pump over the LFRS B-types appliance 2000lpm pumps.

The strategy should also consider pairing appliances with larger pump capacity to ALP's to improve water tower performance as demonstrated in appendix 2, test 2.

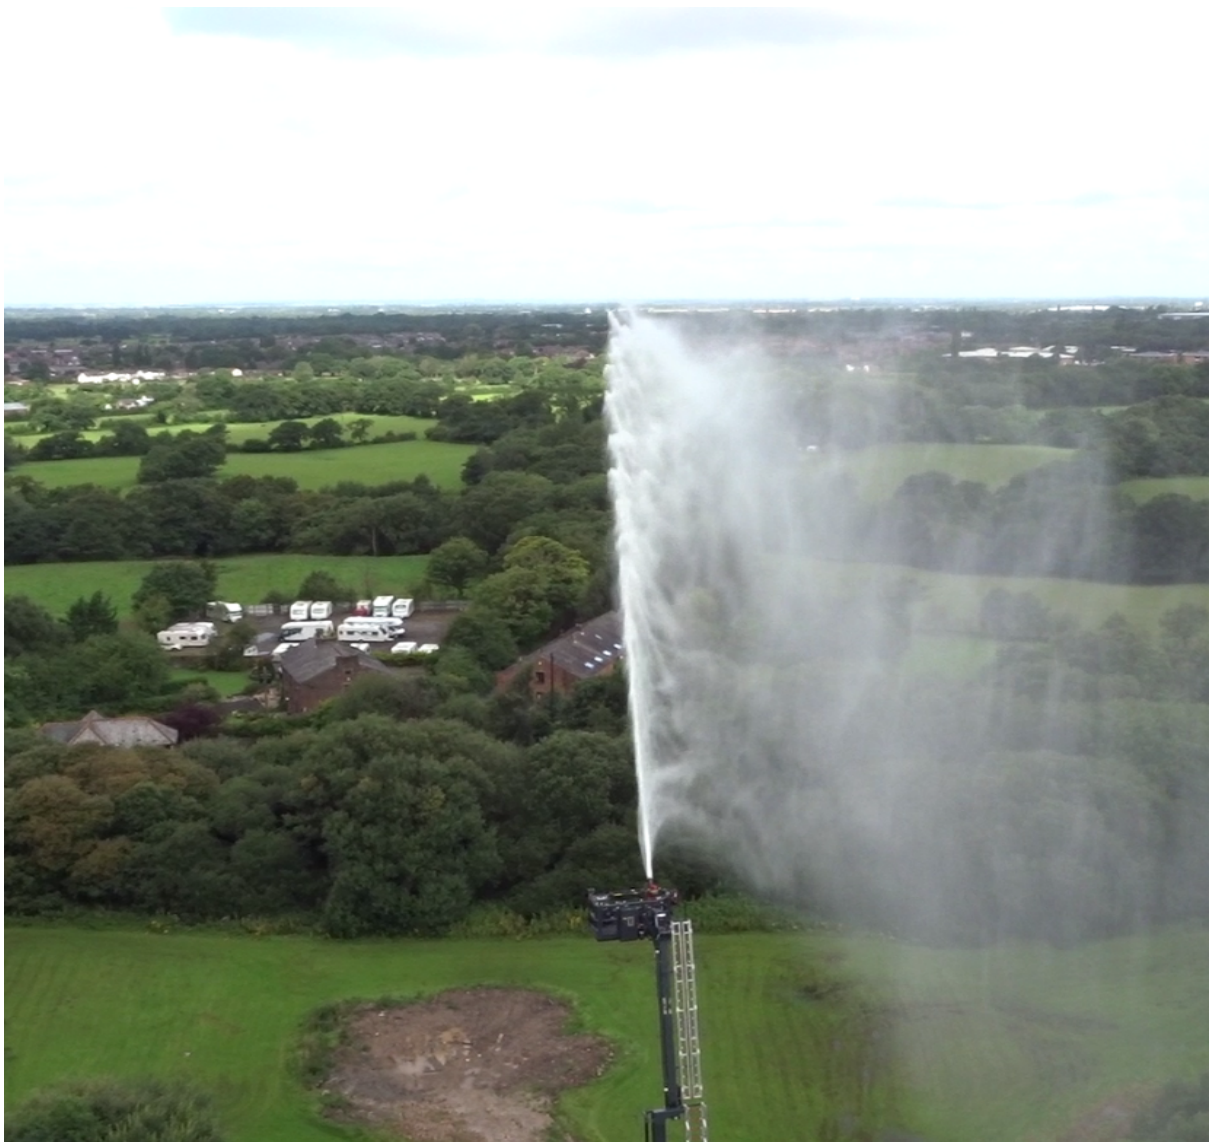
Test 3

Metz ALP @ 32m fed from Stinger by 4 x hoses at 12 bar:

Flow 2600 ltr

Height 54m

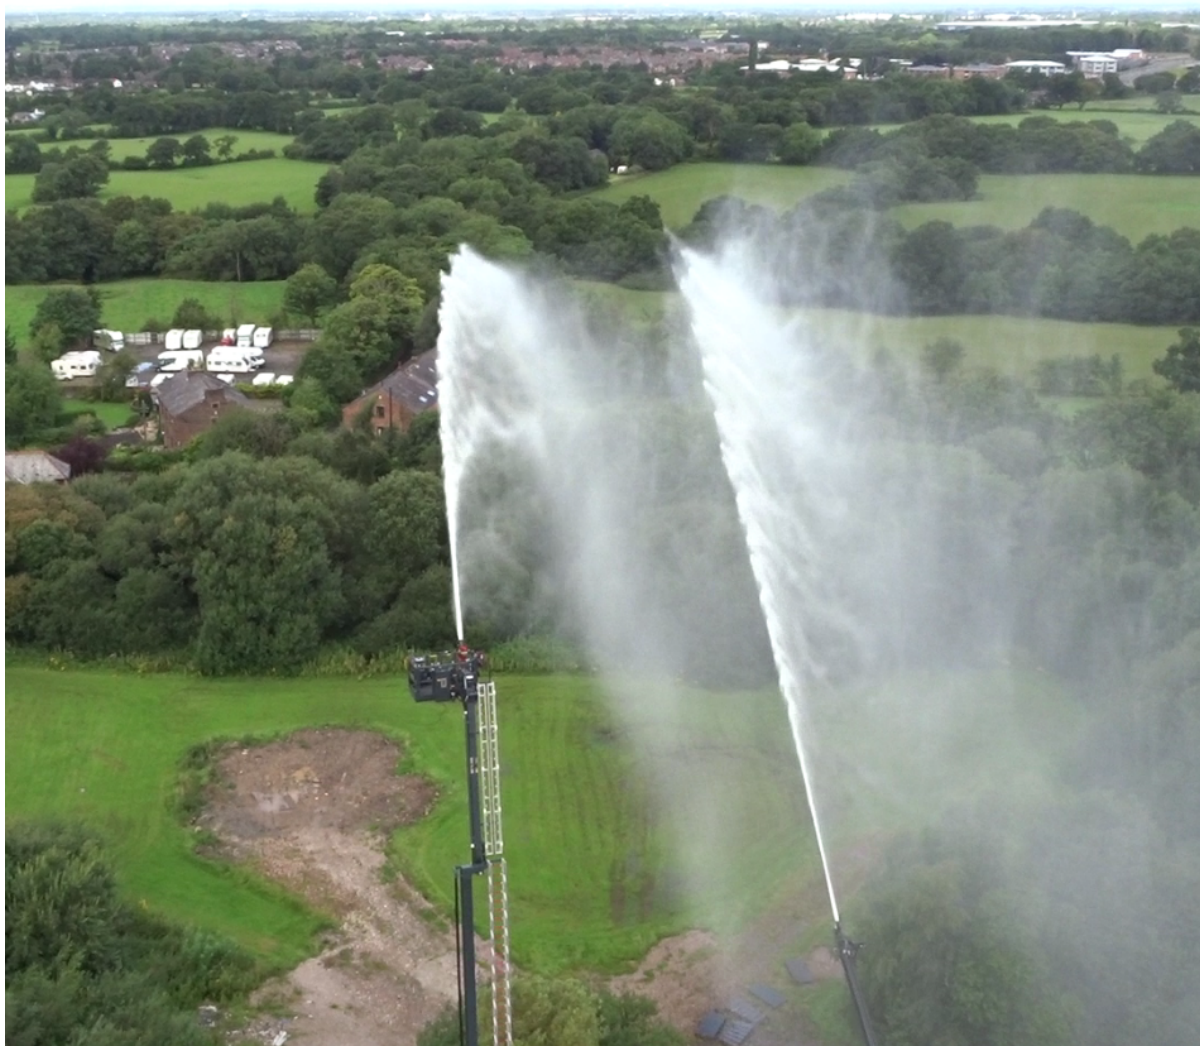
Test 4

As Test 3 and also Stinger Nozzle being fed at full power

ALP Flow 1800 ltr
Height 40m

The final test worthy of note is, Test 4. This shows the WT feeding the ALP whilst delivering water through its own boom package. Both boom packages are in the vertical position as in previous tests and a strong firefighting jet can be achieved by both vehicles at a height of 40m. With LFRS current WT capability, four vehicles would be required, i.e. two ALP's and two appliances with 2000lpm pumps. Using the ALP and WT combination not only improves performance, it is a more cost effective arrangement in the fact that only two vehicles are required.
